# Gate oxide degradation of SiC IGBT induced by non-constant thermal-electrical coupled stresses

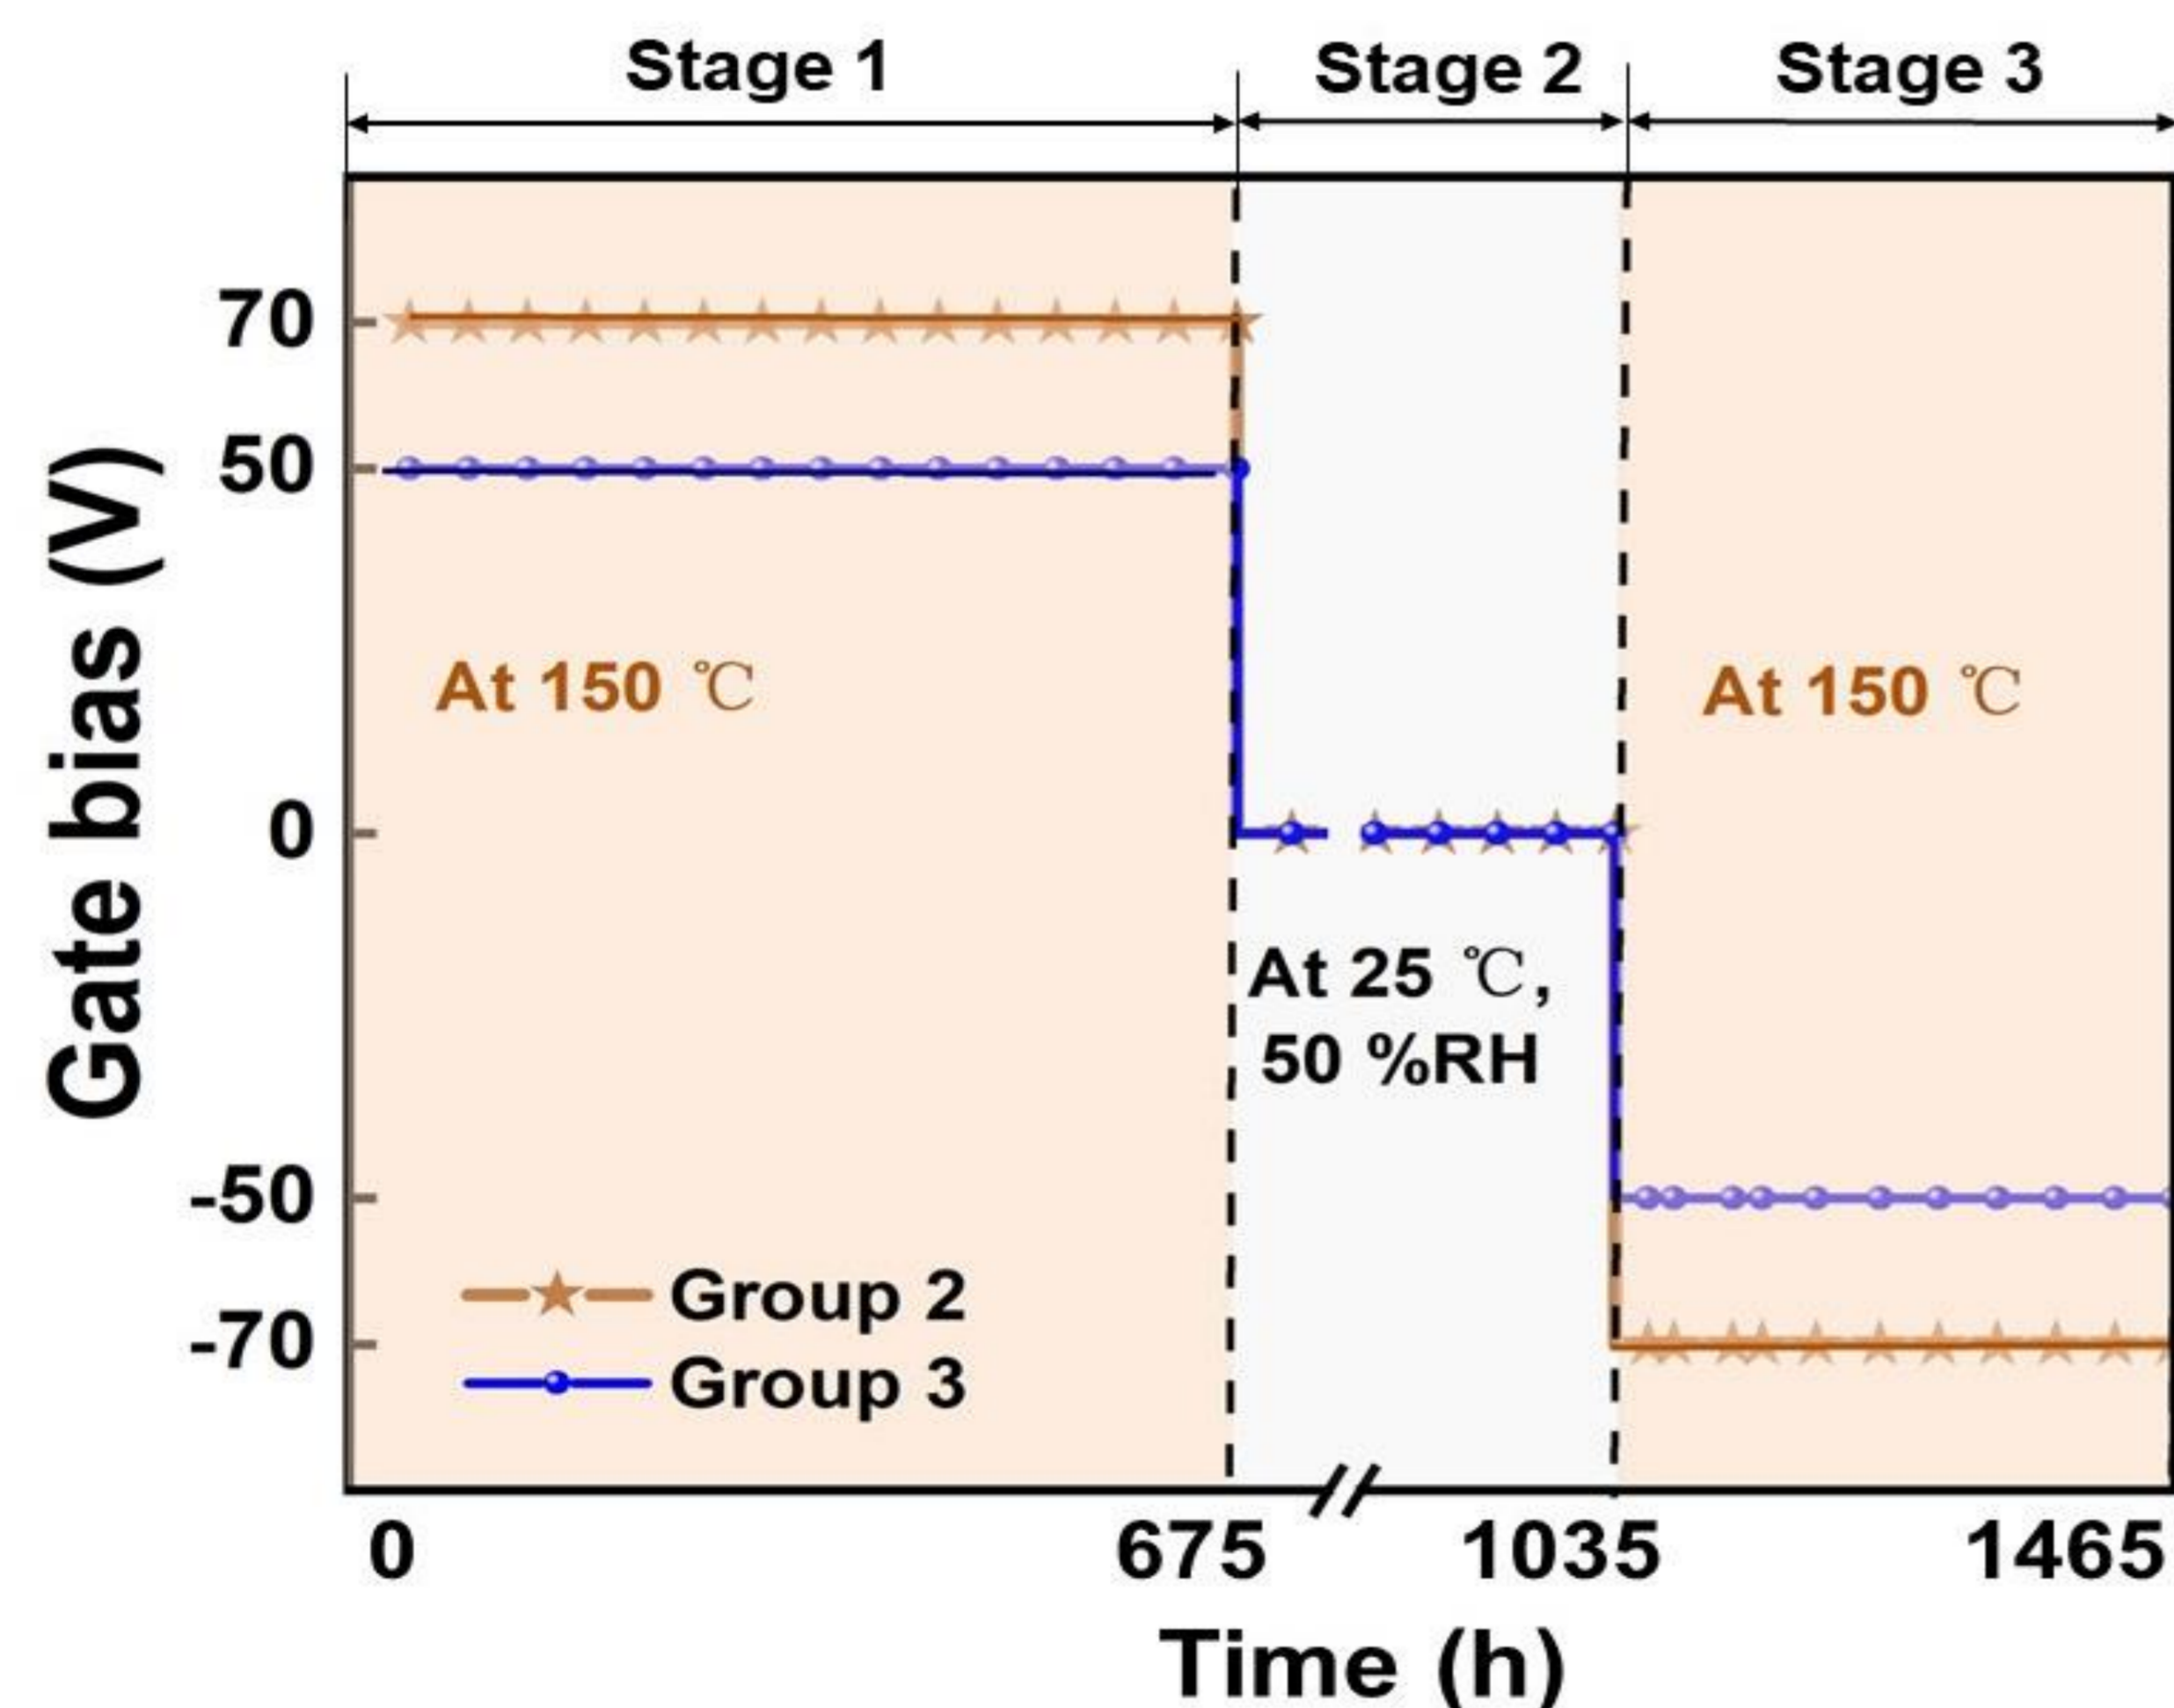
**Figure 1** The non-constant thermal-electrical coupled stresses profile for Group 2 and Group 3

DUTs of Group 1 were exposed to **constant thermal stress** only, for comparison to Group 2 and Group 3. The DUTs of Group 2 and Group 3 were exposed to **non-constant thermal-electrical coupled stresses**, more specifically, the progress of the tests included 675h of HTGB test under positive gate bias (**Stage 1**, Group 2: +70 V, Group 3: +50 V), 15 days of recovery under 25 °C/50 %RH (**Stage 2**), and 430h of HTGB test under negative gate bias (**Stage 3**, Group 2: -70 V, Group 3: -50 V), the thermal-electrical coupled stresses profile can be seen in **Figure 1**, with the high temperature gate bias (**HTGB**) and high temperature storage stress (**HTSS**) tests condition clarified.

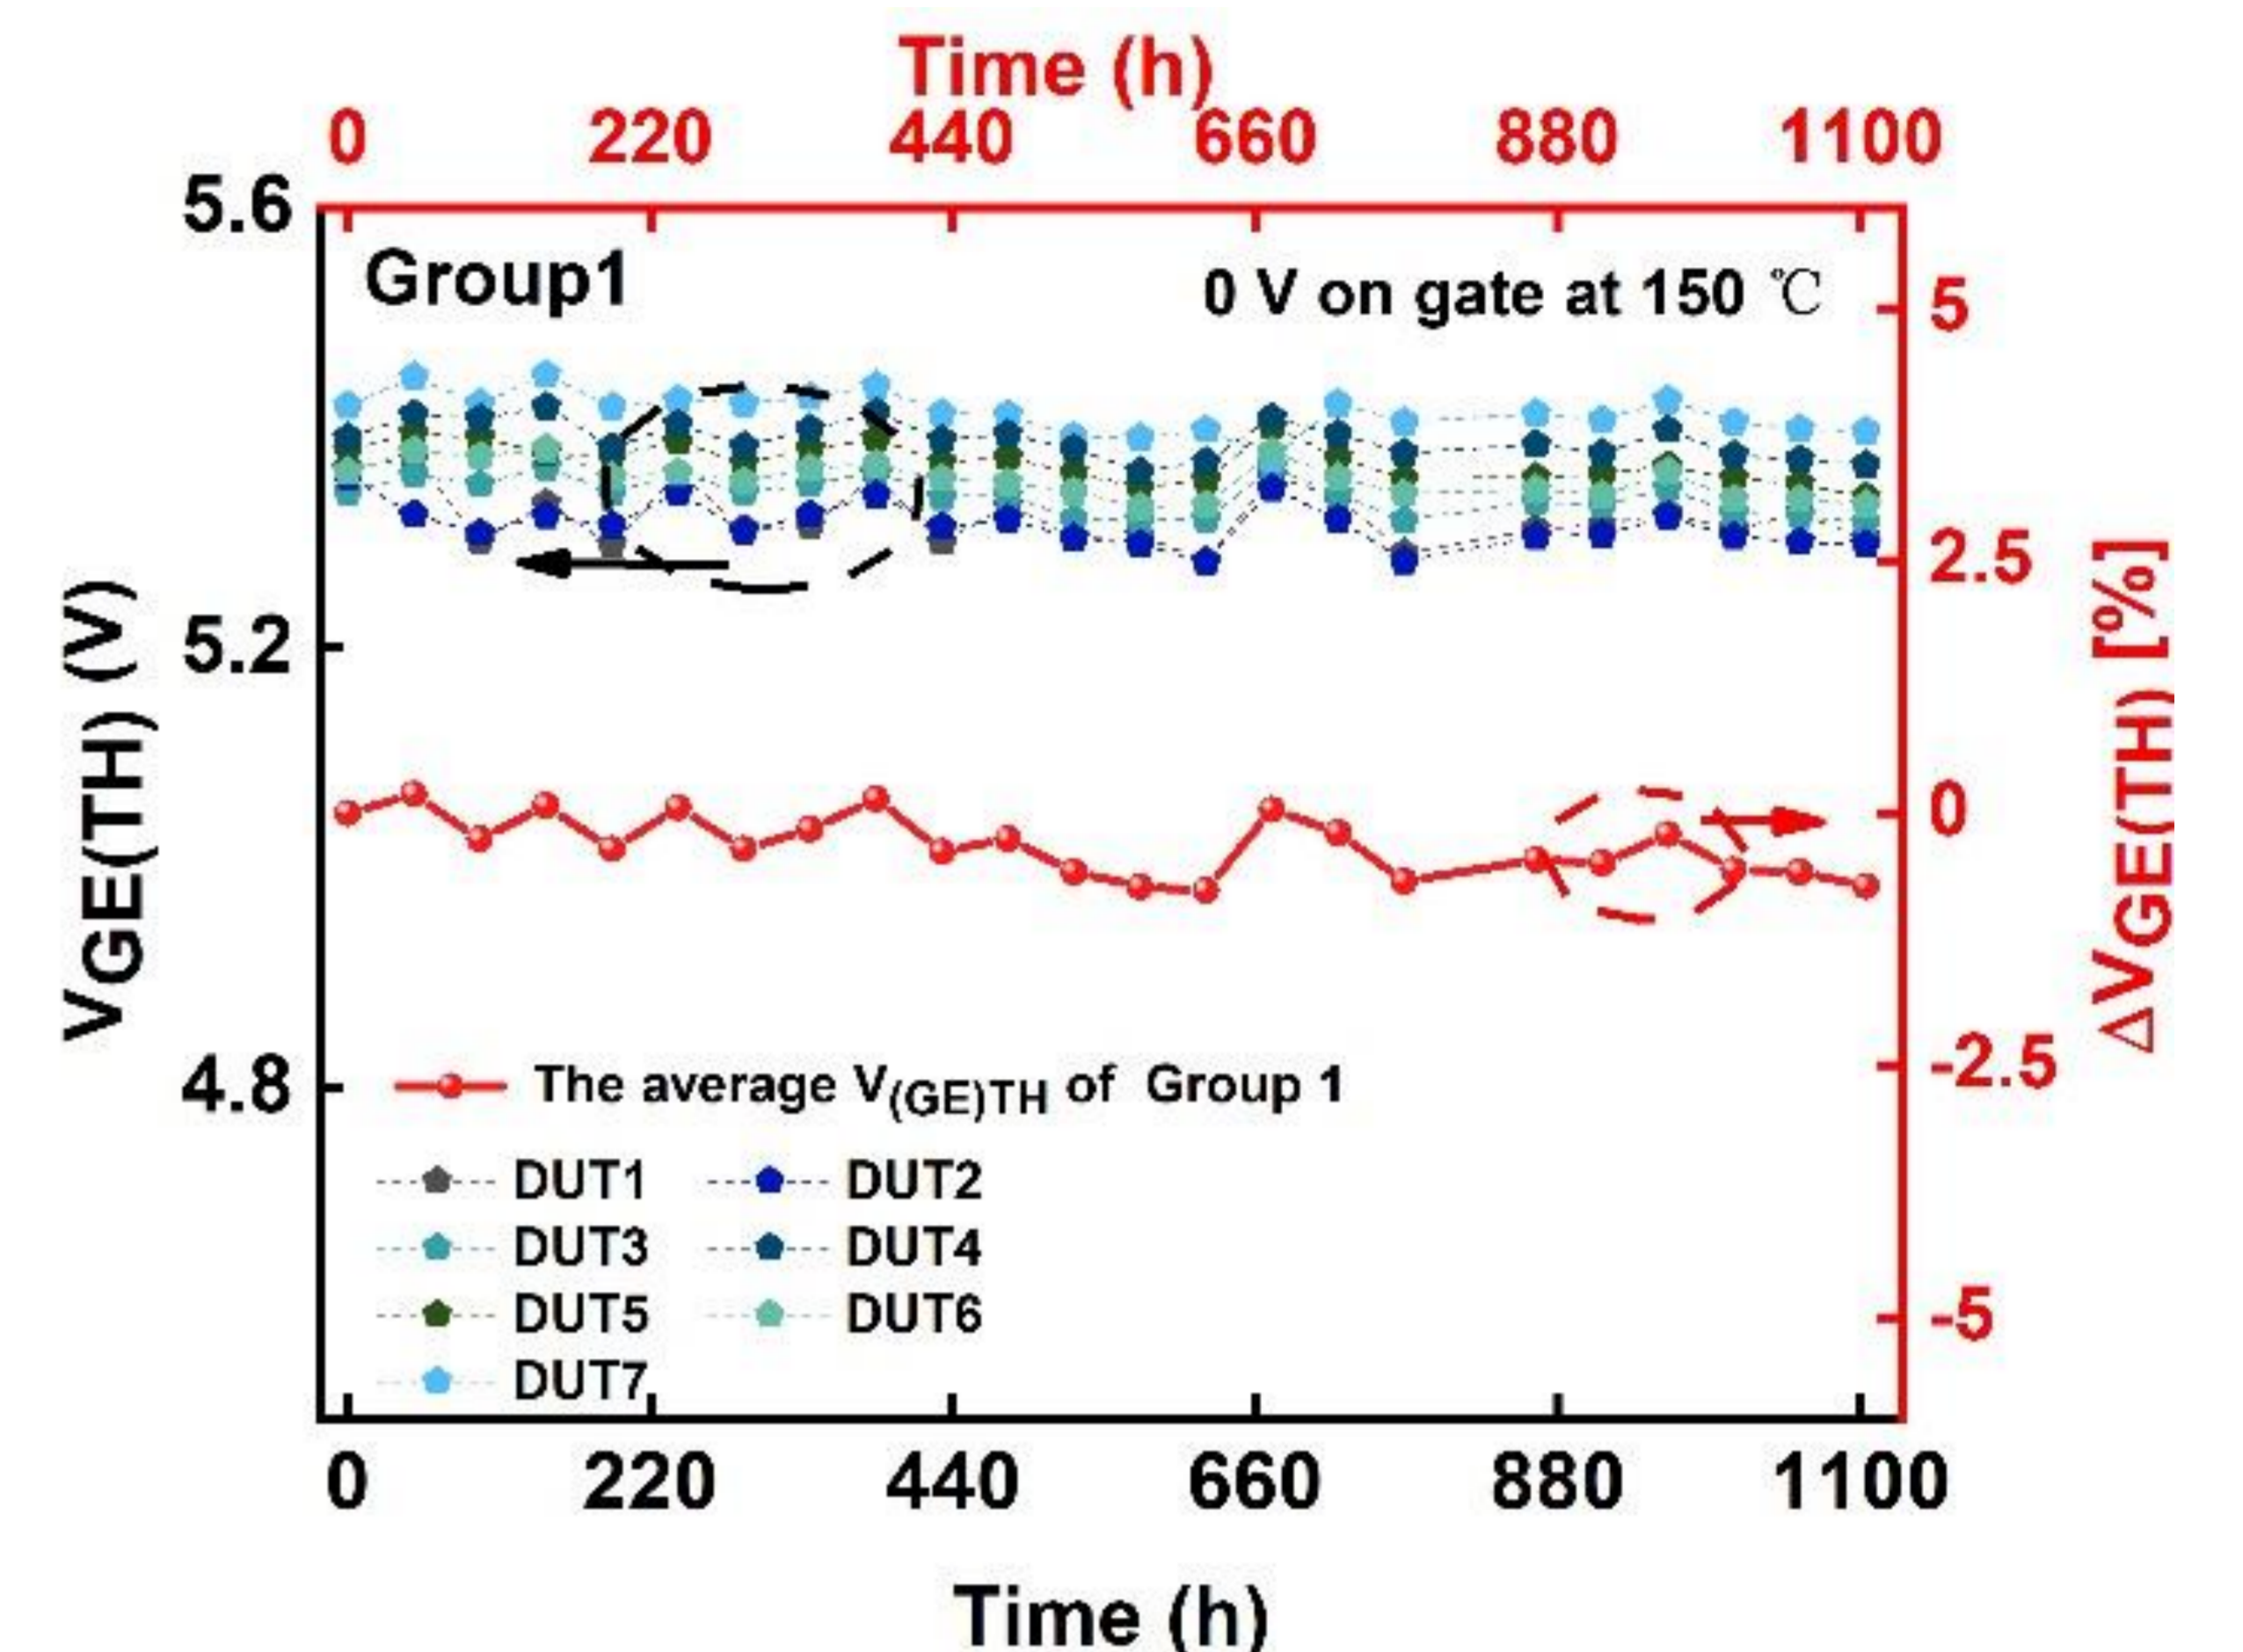
**Figure 2** The  $V_{GE(TH)}$  and the average  $V_{GE(TH)}$  change ( $\Delta V_{GE(TH)}$ ) of Group 1 as a function of time under constant temperature (150 °C)

The variation of  $V_{GE(TH)}$ , and the change of the average  $V_{GE(TH)}$  ( $\Delta V_{GE(TH)}$ ) over time for Group 1 are shown in **Figure 2**. After the HTSS tests (1100 h),  $V_{GE(TH)}$  decreased slightly, with an average  $V_{GE(TH)}$  of 5.334 V, a change of only -0.726%. The average change of  $V_{GE(TH)}$  ( $\Delta V_{GE(TH)}$ ) during the overall tests period for Groups 2 and 3 is displayed in **Figure 3**. The  $V_{GE(TH)}$  of Group 2 and Group 3 changed by 2.37% and 0.68%, respectively, after the positively biased HTGB tests (Stage 1). When a negative bias is applied (Stage 3), the  $V_{GE(TH)}$  decreases. The drifts in  $V_{GE(TH)}$  under negative gate bias stress are significantly larger than those under positive, and the average variations ( $\Delta V_{GE(TH)}$ ) of Groups 2 and Group 3 are -8.89% and -6.21%, respectively.

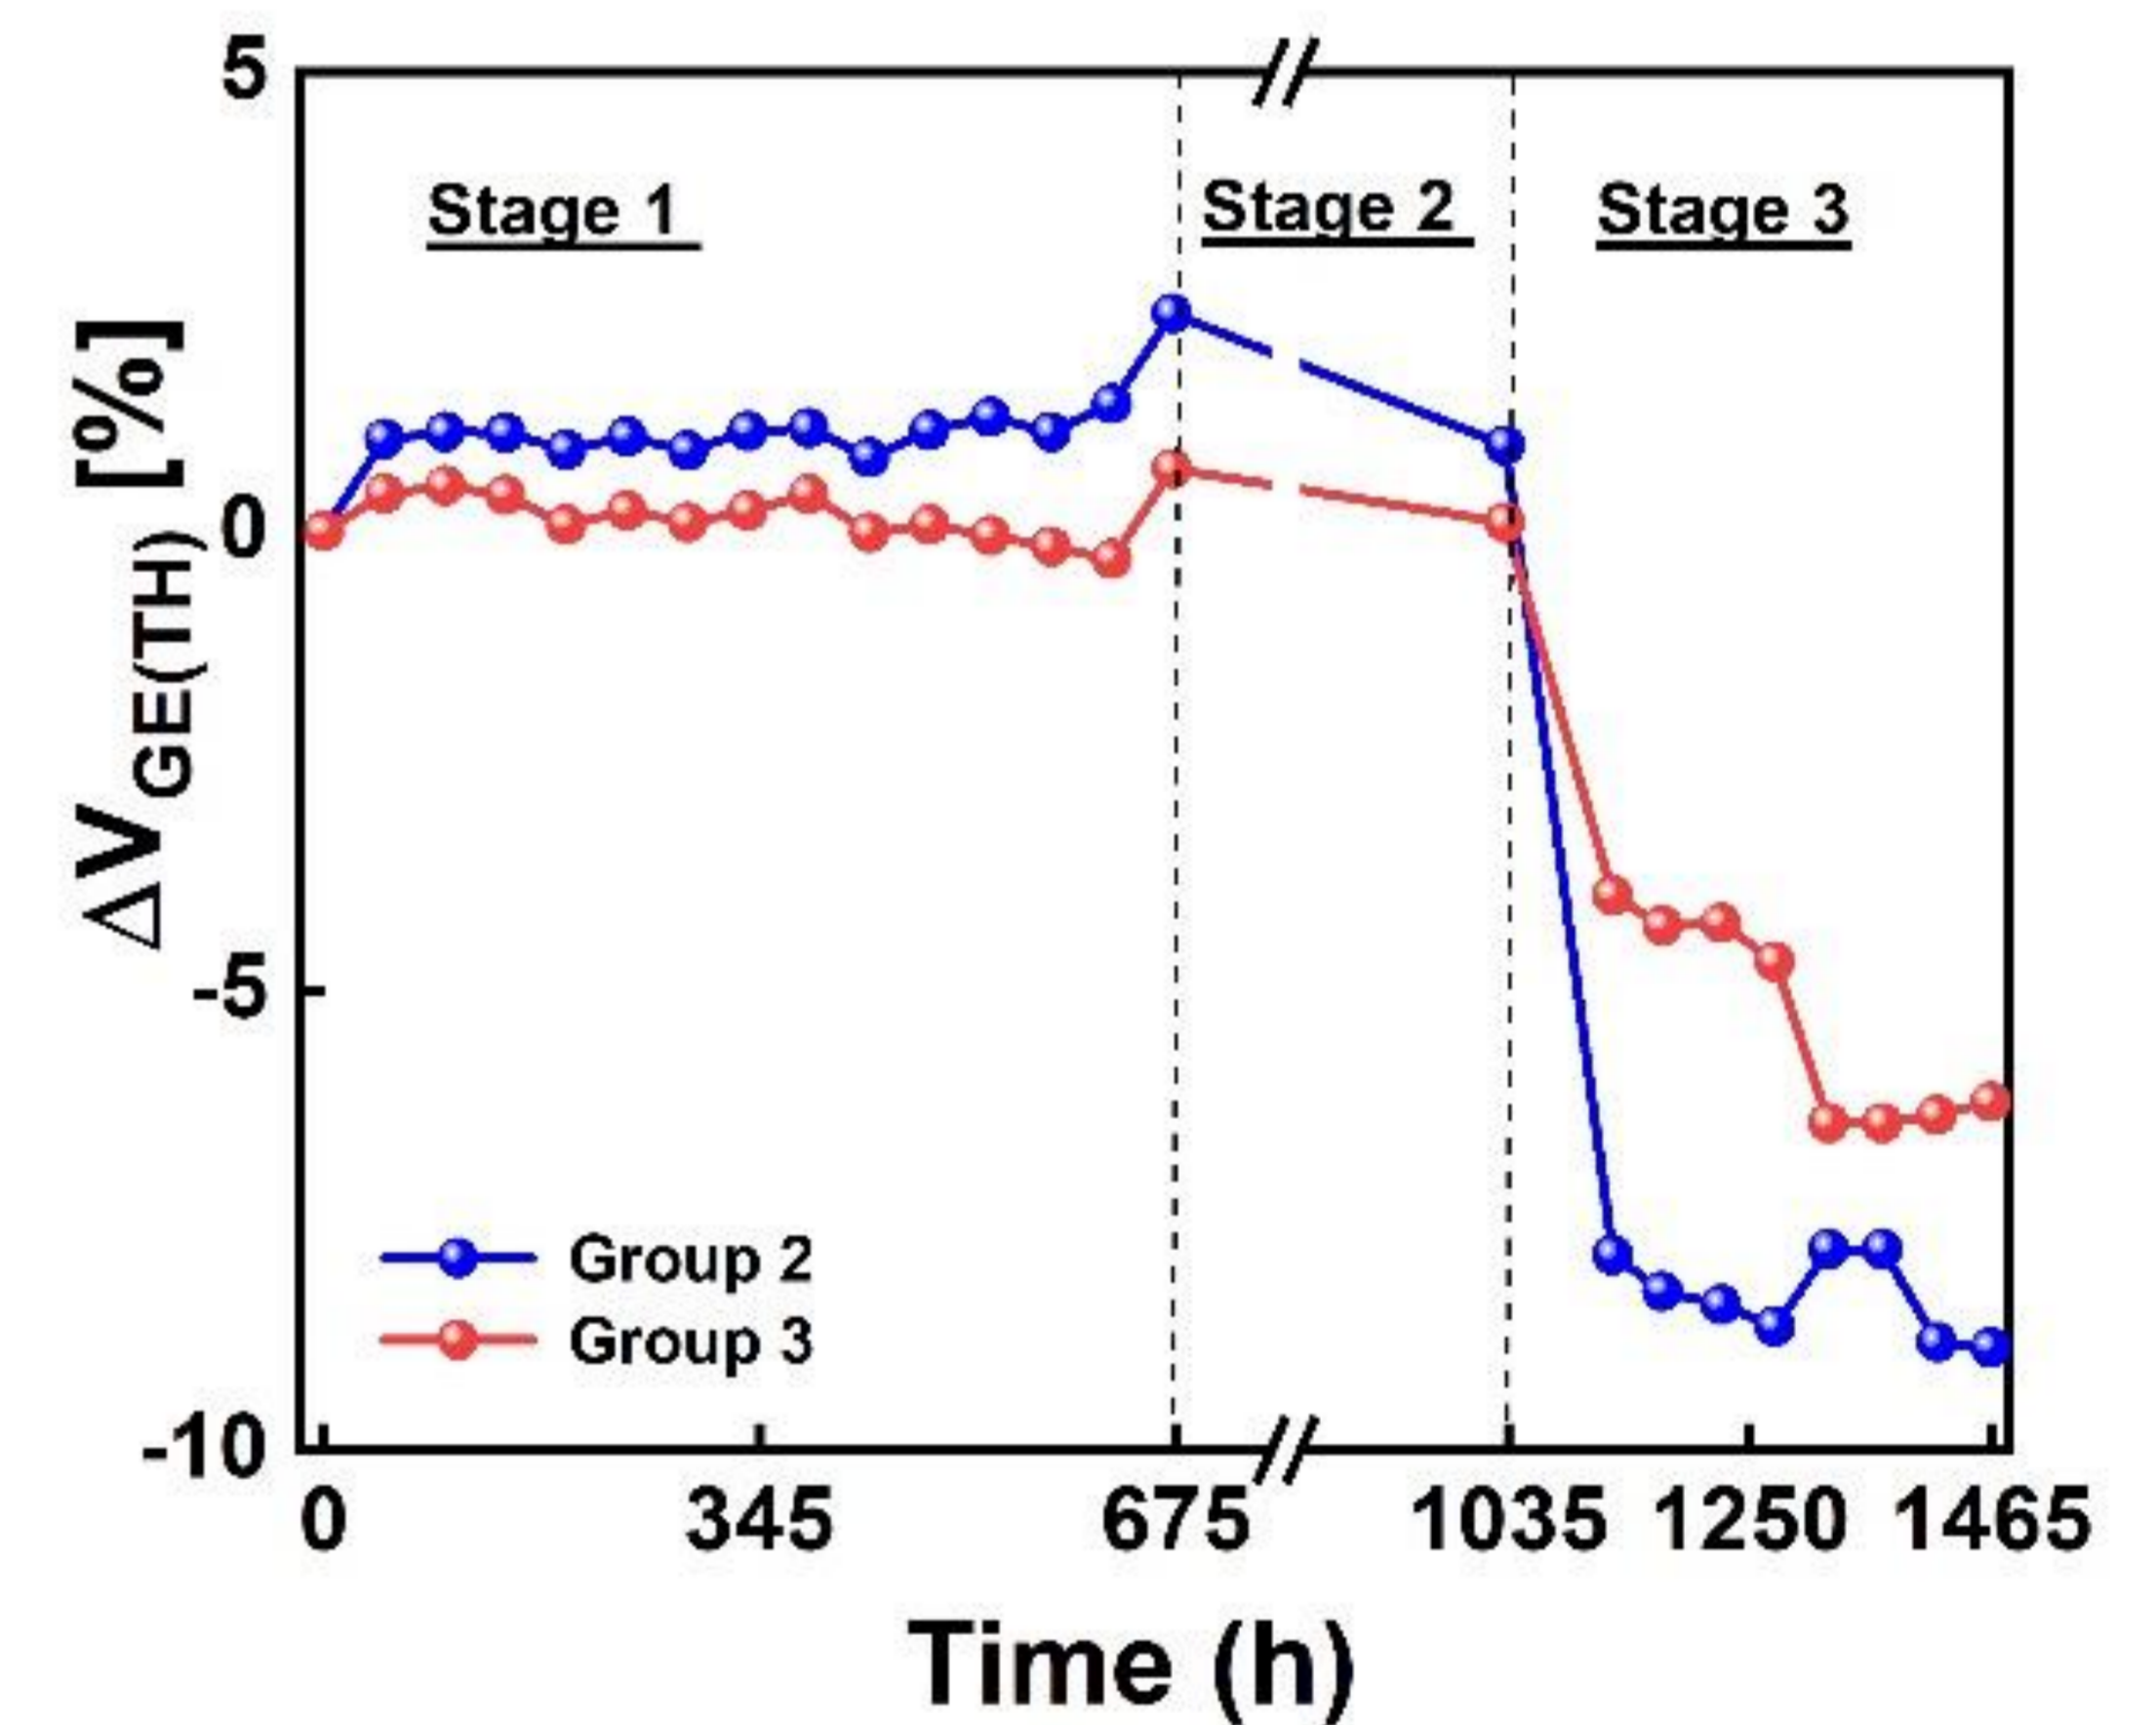
**Figure 3** Measured changes of the average  $V_{GE(TH)}$  ( $\Delta V_{GE(TH)}$ ) of Group 2 & Group 3

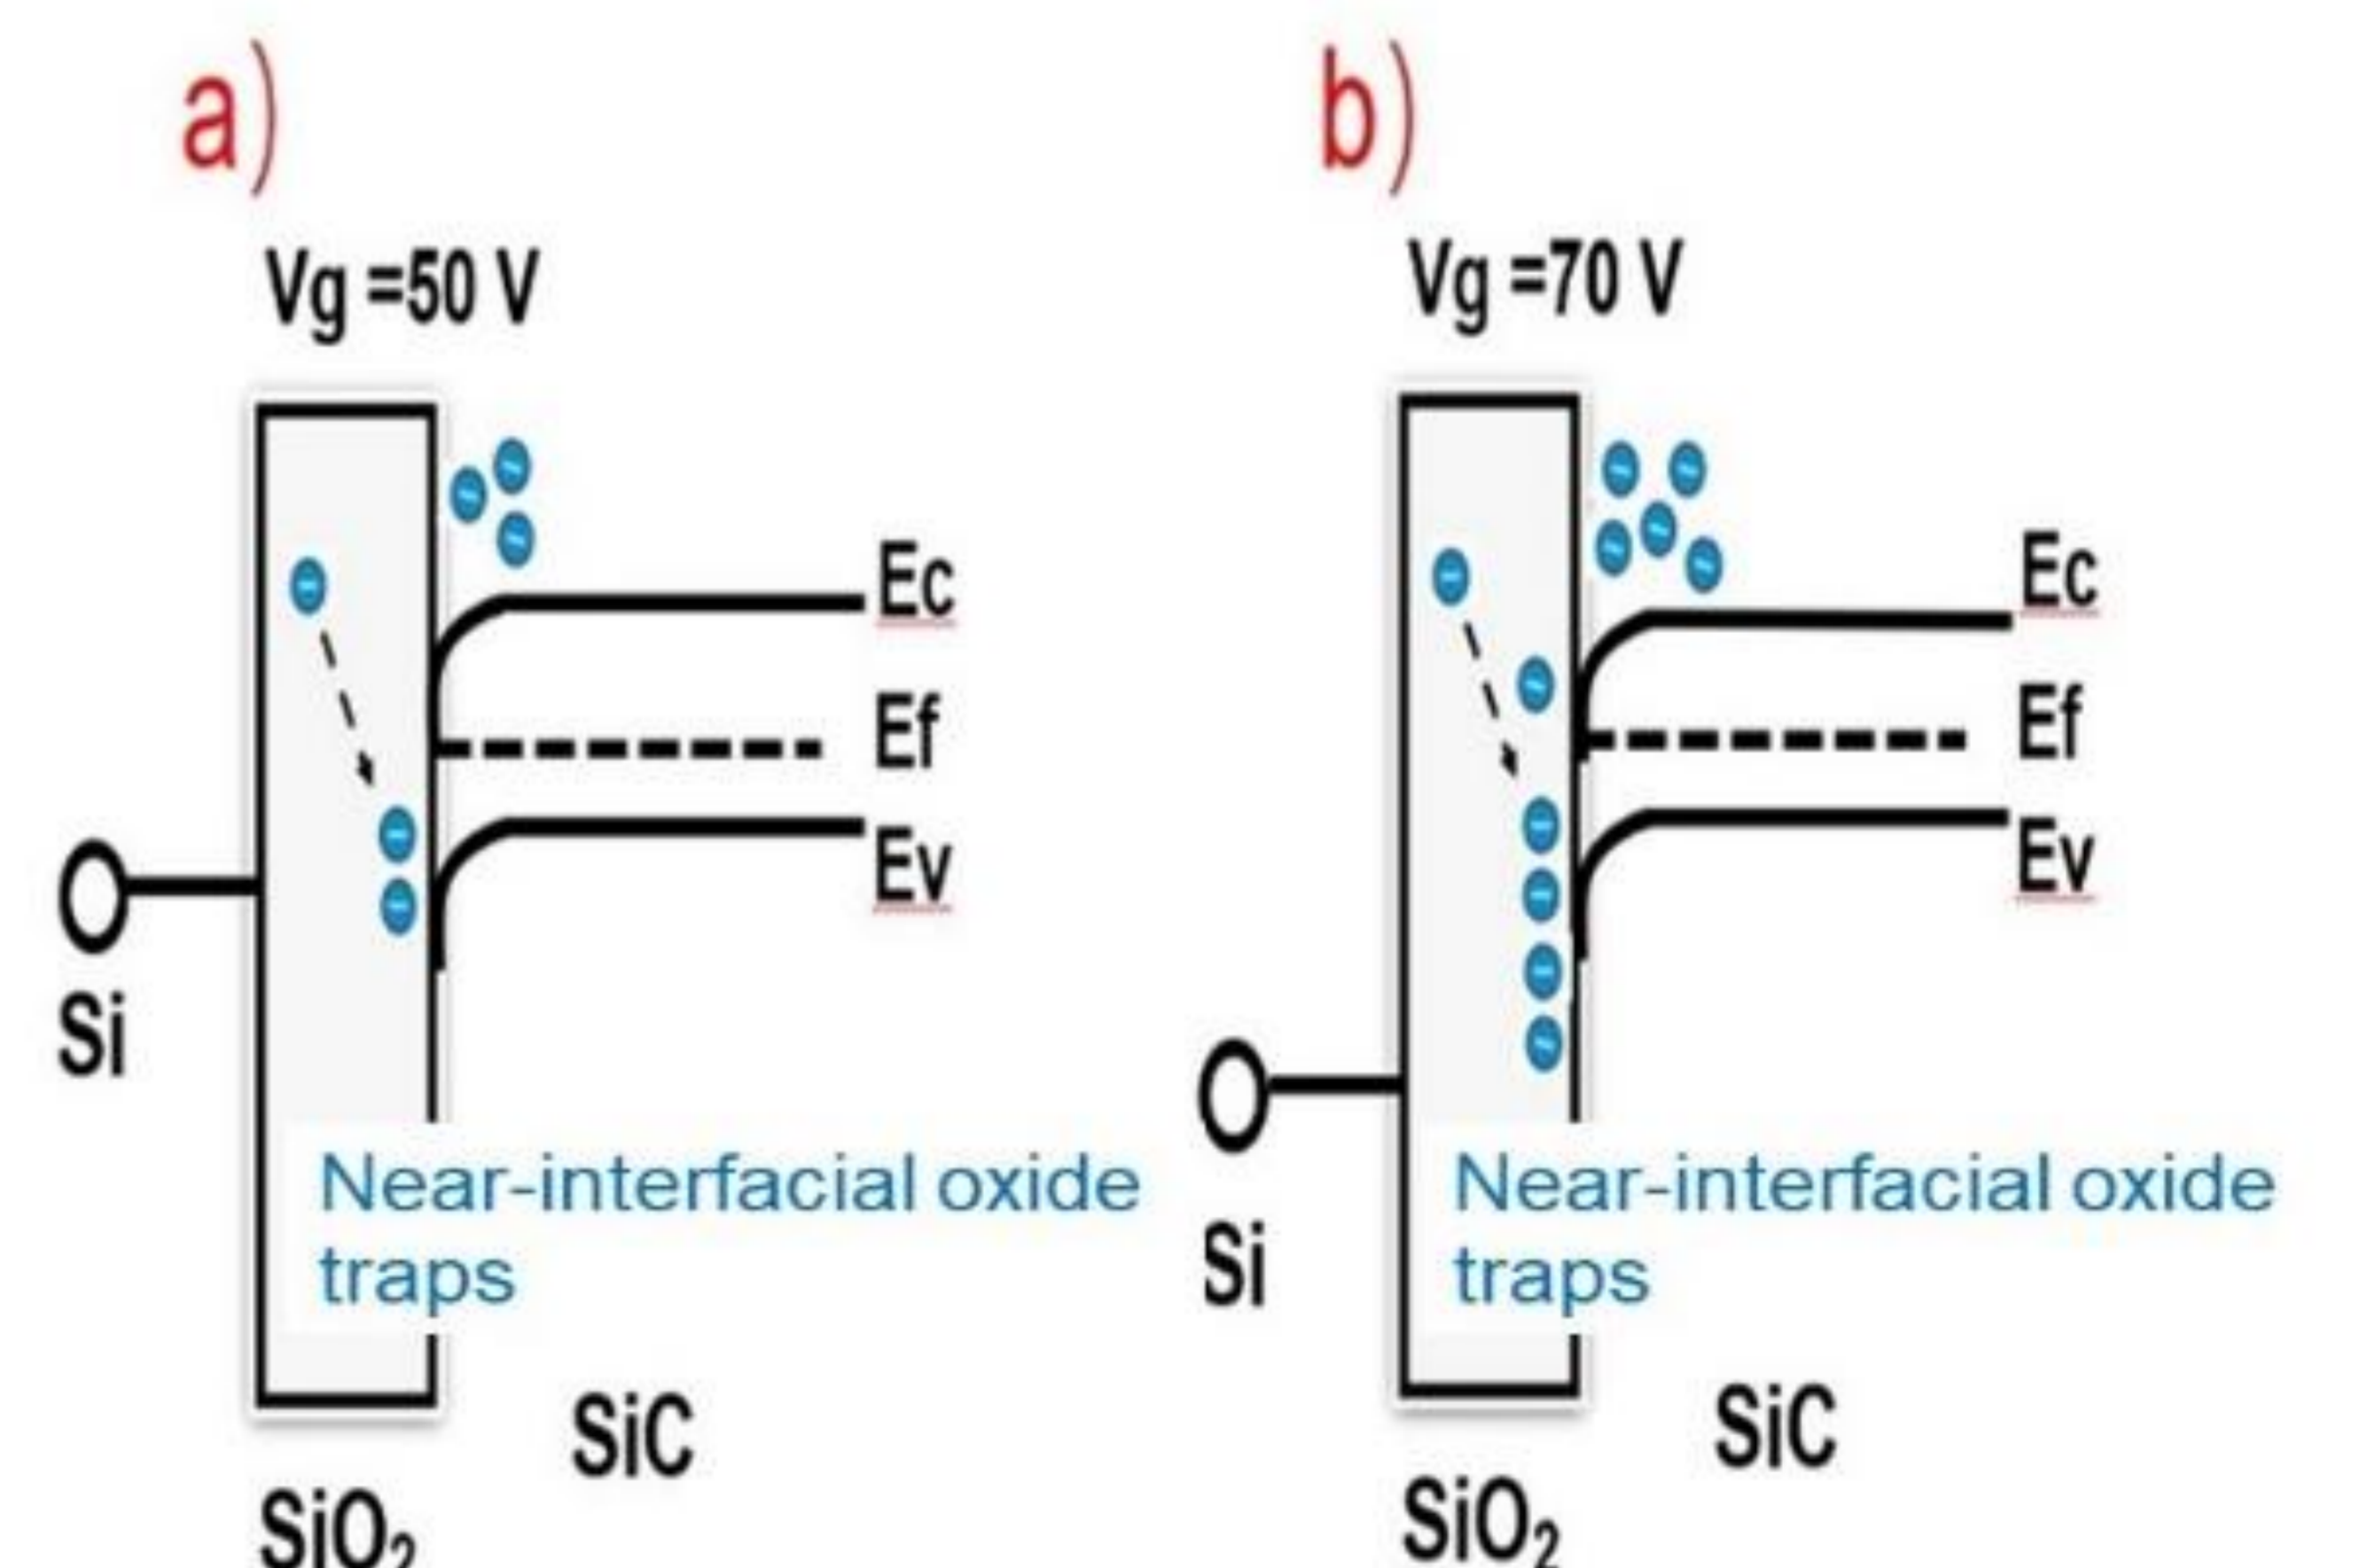
**Figure 4** Energy band diagrams for the DUTs under two positive gate bias stresses: a)  $V_g=50$  V and b)  $V_g=70$  V

The energy band diagram of the gate region can explain the  $V_{GE(TH)}$  instability during HTGB tests. As shown in Figure 4, when a positive gate voltage is applied, which indicates the formation of an **electron-stacking region** in the semiconductor. Under thermal-electrical coupled stresses, electrons are trapped by the near-interfacial oxide traps at or near the SiC/SiO<sub>2</sub> interface. The electron trapping capability **increases** with increasing gate voltage.

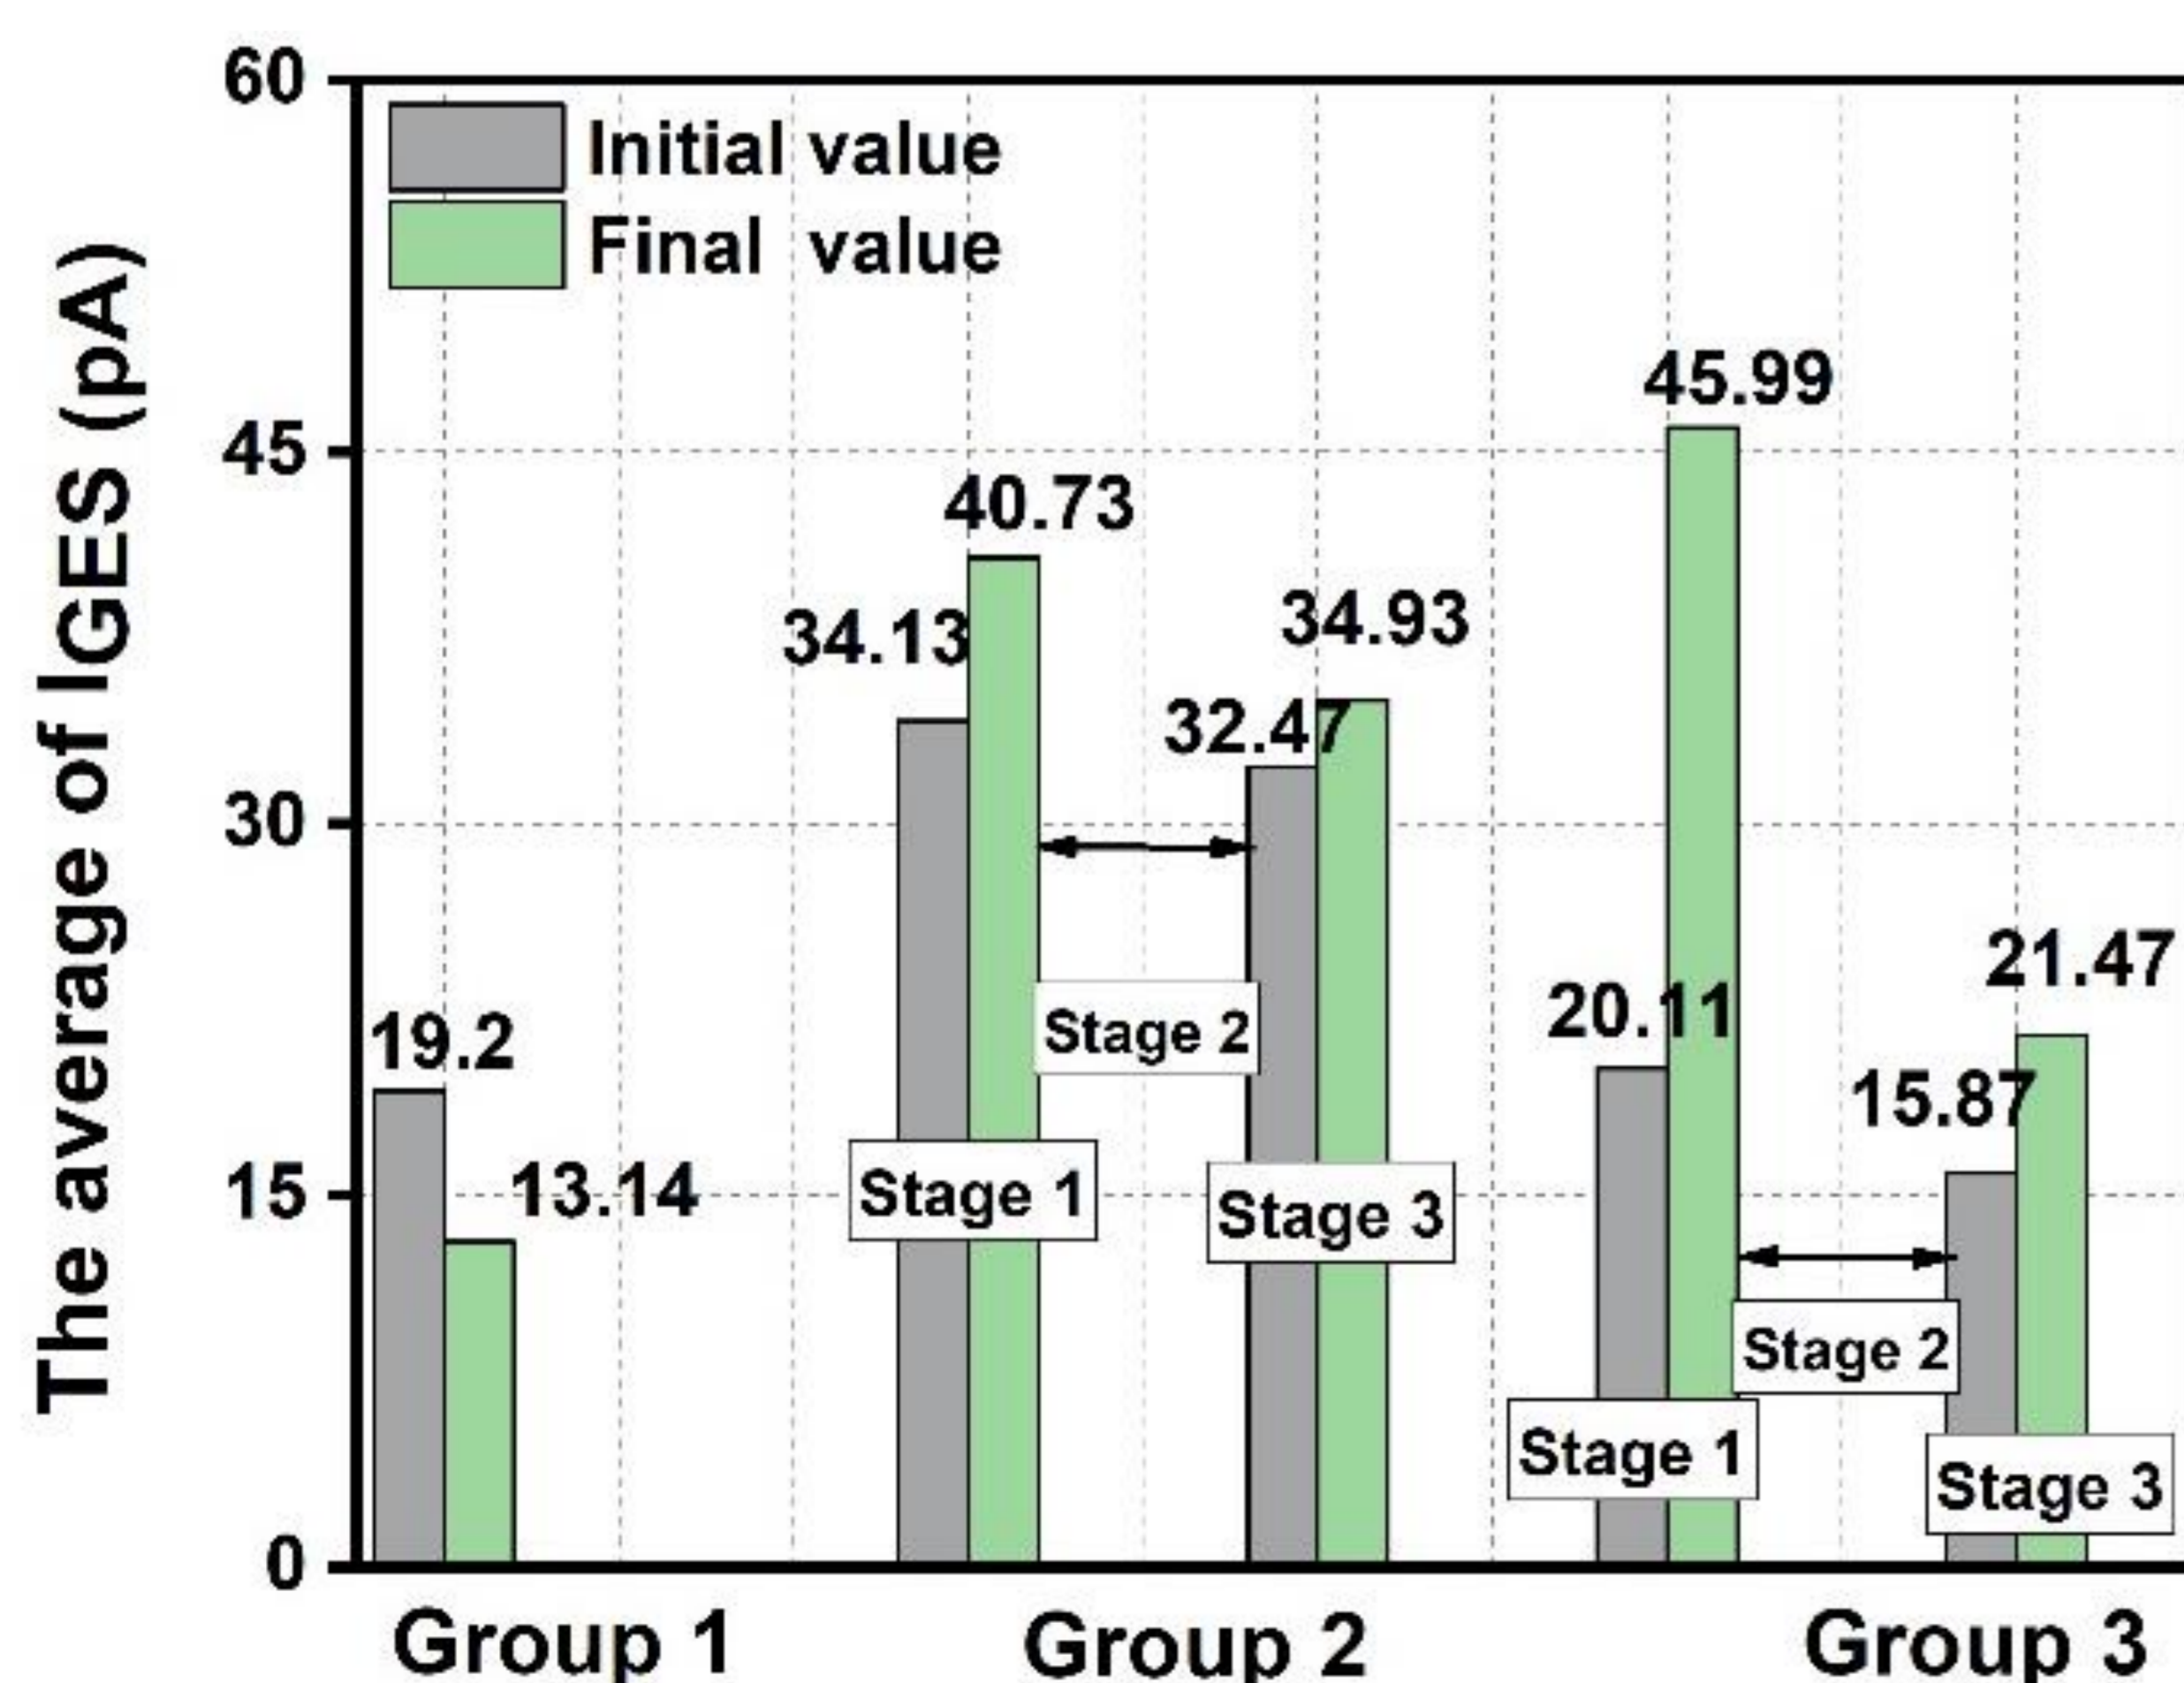
Figure 6 Comparison of the average  $I_{GES}$  among the three groups before and after tests

In addition, either the increase of leakage current (always with a magnitude of pA) or the decrease of breakdown voltage can be ignored for SiC IGBTs in this study, indicating no permanent damage existing after the accelerated tests.
